Manhole Inspection Summary

Manhole # S29K__073MH

Insp Date: **1/27/09 1:29 PM**

Location Address: **1017 Ramsay St**

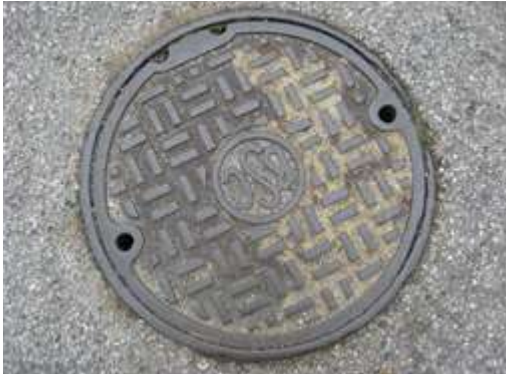
Miscellaneous

cover pic

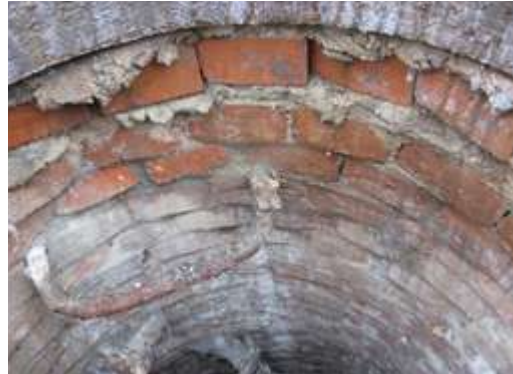
Defect 2

Count: **8** Missing: **1** ☒ **Corroded**

corroded rungs, 1 missing rung

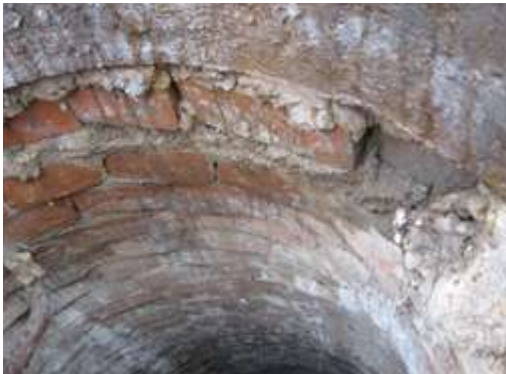
Defect 3

Condition: ☐ Sound ☐ Cracked ☐ Root Intrusion ☒ **Loose Brick** ☒ **Deteriorated**

chimney has loose/missing brick

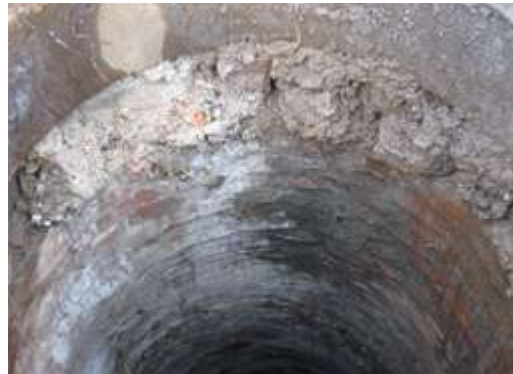
Defect 1

Offset: **2** (in.)

frame offset; chimney deteriorated with infiltration from mortar

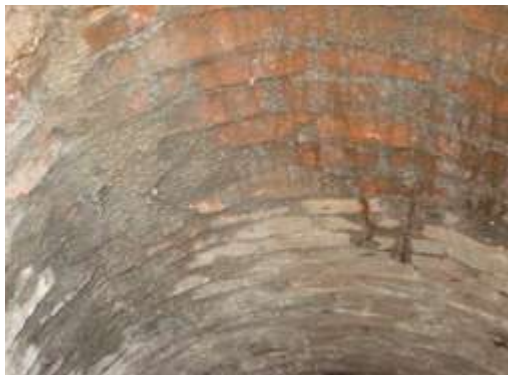
Defect 5

Infiltration: ☐ None ☐ Joint ☐ Cracks ☒ **Mortar** ☐ Roots ☒ **Wall**

corbel infiltration from mortar & wall

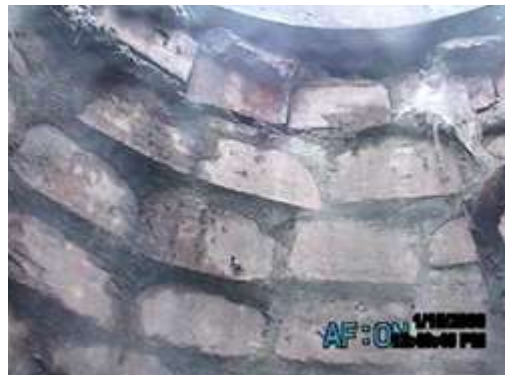
Defect 4

Infiltration: ☐ None ☒ **Joint** ☐ Cracks ☒ **Mortar** ☐ Roots ☐ Wall

chimney joint infiltration

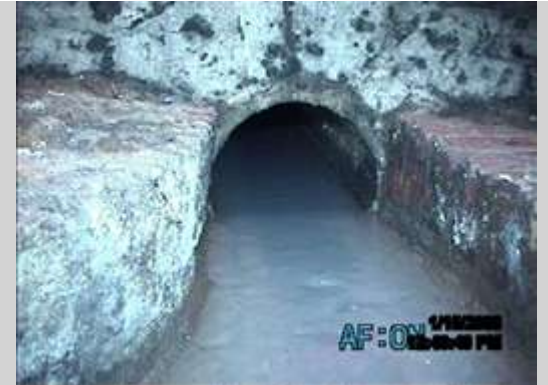
12 O'Clock Outflow

Pipe Height: **8.4** (in.) Rod and Bar (Angled)
Pipe Material: **Clay** ☐ Pipe Lined
Invert Depth: **11.04** (ft.) Flow Characteristics: **Slow**
Deposits: ☒ None ☐ Mud ☐ Sludge ☐ Debris ☐ Grease
Silt Depth: **0** (in.) Deposits Extent:
Infiltration: **None** Pipe Seal Cond: **Sound**

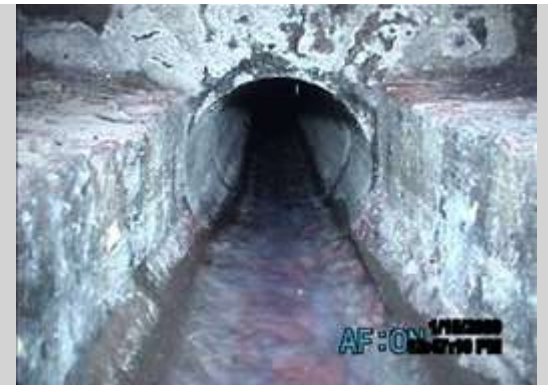
6 O'Clock Inflow

Pipe Height: **8.4** (in.) Rod and Bar (Angled)
Pipe Material: **Clay** ☐ Pipe Lined
Invert Depth: **10.56** (ft.) Flow Characteristics: **Slow**
Deposits: ☒ None ☐ Mud ☐ Sludge ☐ Debris ☐ Grease
Silt Depth: **0** (in.) Deposits Extent:
Infiltration: **None** Pipe Seal Cond: **Sound**

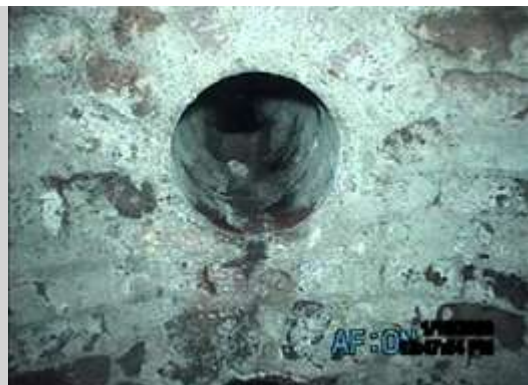
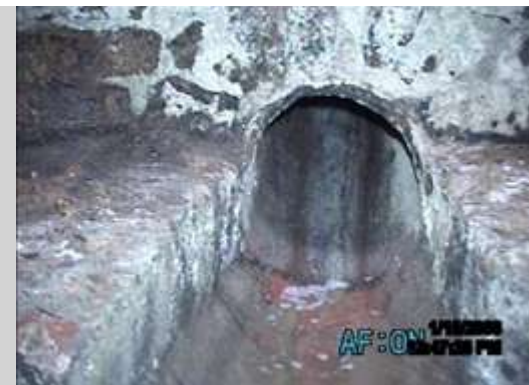
9 O'Clock Inflow

Pipe Height: **8.4** (in.) Rod and Bar (Angled)

Infiltration: **None** Pipe Seal Cond: **Sound**

Drop: Outside	Rod and Bar
Angled: Yes	Reading: 9.40 (ft.)
	Inv Depth: 10.40 (ft.)
Drop Condition: Open
